STEP 5-3 Tail Rotor Pushrod & Support Guides

Final Assembly

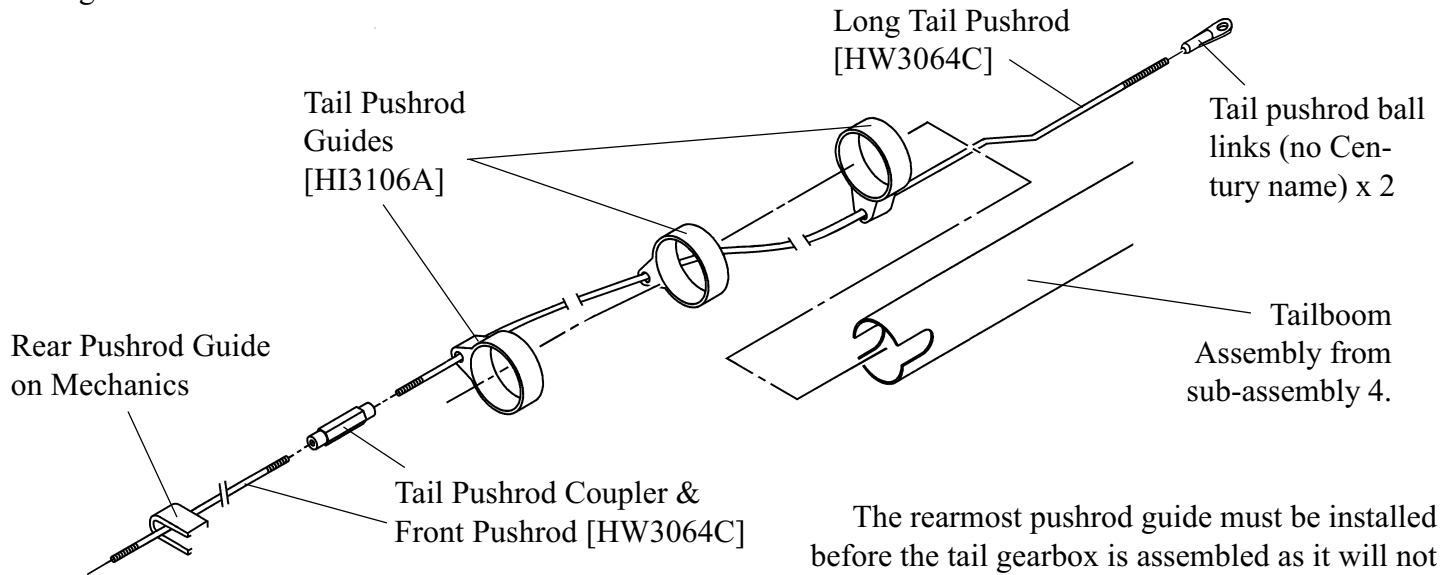
Slide the three tail pushrod guides onto the tail boom, position each guide to allow the pushrod to rotate from beneath the tailboom at the tail gearbox to beside the tailboom on the right near the main mechanics. Do not glue the guides until the rudder pushrod is installed and moving freely. Slide the front pushrod through the **large molded guide** (the small front guide is no longer used) at the rear of the upper mechanics and thread into the pushrod coupler after the tail boom is installed. Also, after radio set up is complete and the mechanics are inside the fuselage, glue the pushrod guides using a single drop of Zap Ca. One drop will stop the pushrod from binding and still be able to remove them later.

10-20mm be cut off from the threaded sections of the tail pushrod. It is best that after the tailboom is installed, attach both ball links to the ends (no Century name) and **not** attach the pushrod coupler. Attach the ball links to the steel balls on the servos according to the rudder setup instructions and then see how much thread must be cut off. Remember that each threaded section can be trimmed up to 5mm but always err on the safe side.

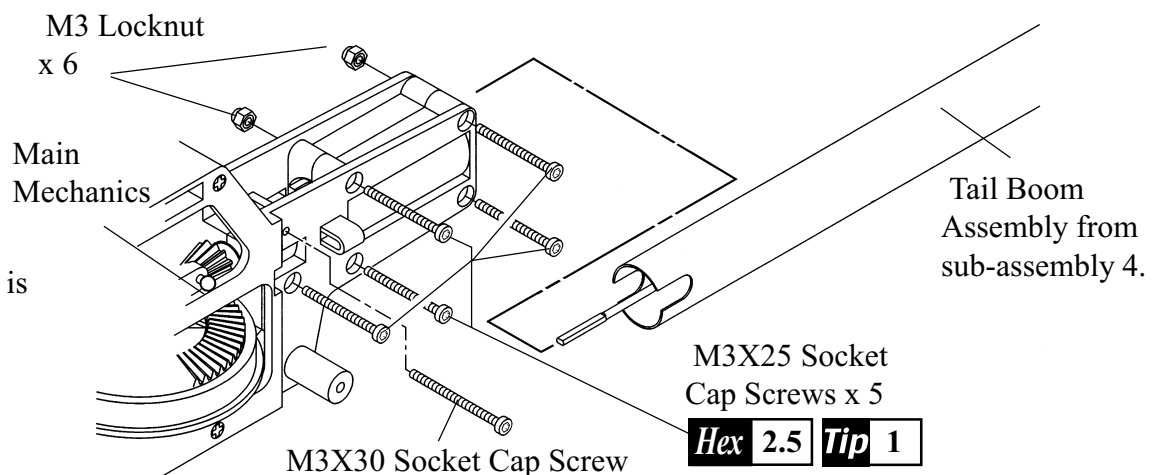
STEP 5-4 Tail Boom Assembly

Attach the tail boom assembly to the main mechanics by sliding the tailboom tube into the mounting hole at the rear of the upper frame using five M3x25 Socket Cap Screws, one M3x30 Socket Cap Screw and six M3 Locknuts. Slowly press the tailboom in, being careful to engage the flattened end of the drive wire into the slotted tail rotor output shaft. The slots on the end of the tailboom will self align with molded pins inside the upper side frame. Take your time and the wire will slide in. Once engaged, press the tail boom in completely until it is fully seated. Hold the

main gear from moving and try to turn the tail rotor to insure proper engagement, you should not be able to turn the tail rotor. If you can rotate it, the drive wire is probably not properly seated into the slot of the front output shaft.
